## Golden Gate Dam Site

## Dam Site Geology

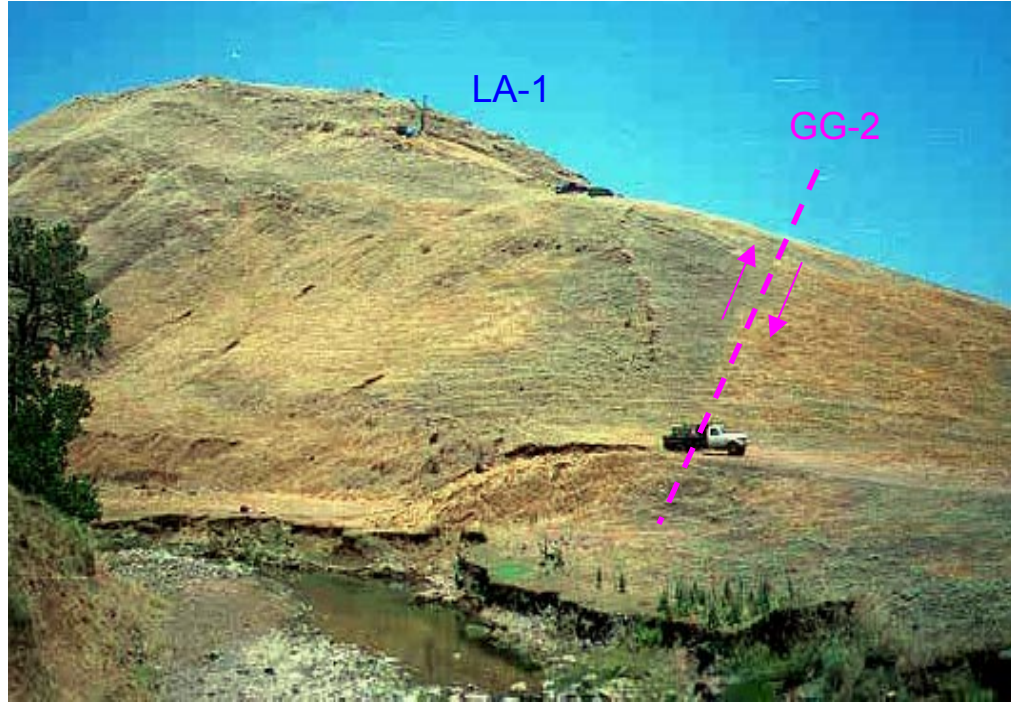
GG-2 tear fault trends N45°E with about 650 feet of apparent right-lateral offset (Photo 10). It trends from the southwest across the right abutment of the straight downstream axis, then continues across the channel slightly downstream of the proposed axis, traversing across the downstream portion of the left abutment, and continuing to the northeast an additional 2 miles. Evidence for this fault includes offsets in sandstone outcrops, small surficial landslides on both abutments, and shearing, gouge, and slickensides encountered in the DWR angle drill hole RC-1 from 73 to 99 feet.

**Photo 10. NE view of GG-2 fault on left abutment of Golden Gate Dam site**

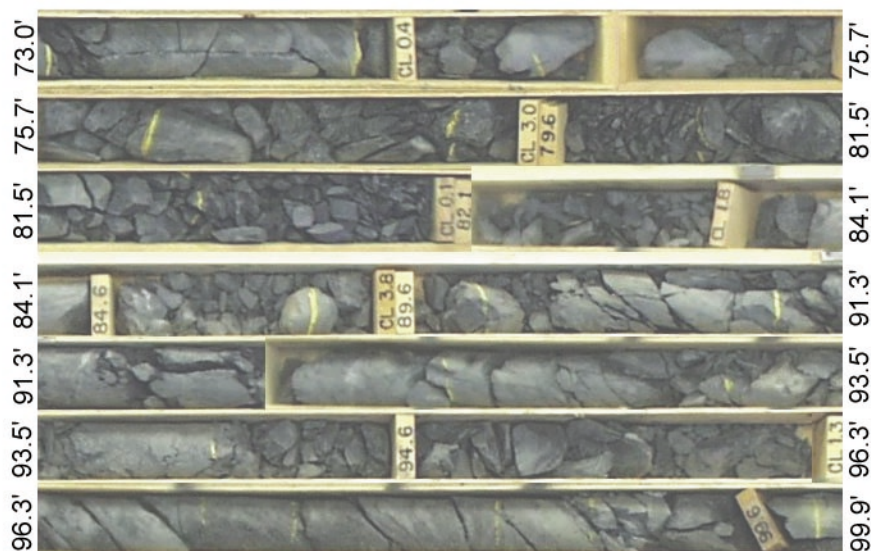
Angle hole RC-1 was drilled at 45 degrees to a depth of 134.6 feet to intercept the GG-2 fault as mapped and to evaluate associated permeability in the foundation (Photo 12). It encountered sandy clay terrace deposits in the initial 32.4 feet. From 32.4 to 123.9 feet, the hole encountered intense fracturing, gouge, and slickensides. It intersected 75 percent mudstone with 25 percent sandstone interbeds. The hole drilled through 100 percent sandstone from 123.9 to 134.6 feet. A 26.4-foot zone of intense fracturing, gouge, and slickensides that probably represents the GG-2 fault was encountered from 73.0 to 99.4 feet (Photo 13). Another zone of intense fracturing that may be related was encountered from 32.4 to 58.1 feet.

Photo 13. Fault GG-2 from 73.0 feet to 99.4 feet in Golden Gate Dam drill hole RC-1

Faults/shears and open fractures uncovered in the foundation may require some cleaning and excavation of weakened and sheared rock before placing embankment foundation. These discontinuities could be potential seepage paths through the foundation and will undoubtedly require grouting. Therefore, a minimal amount of blanket grouting should be considered to seal near-surface fractures and joints.

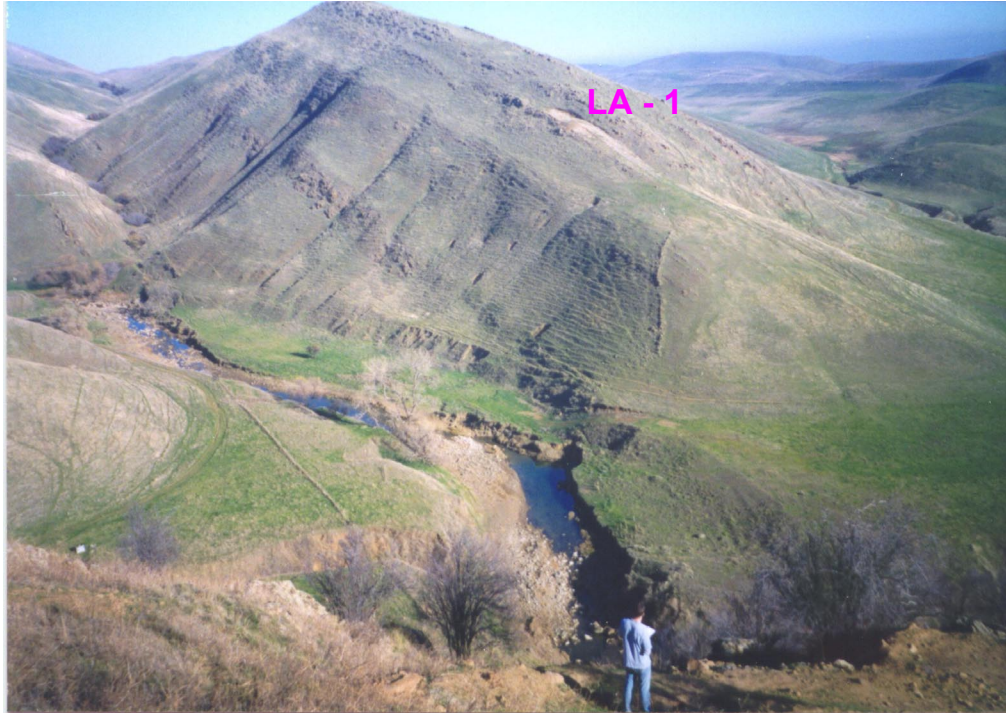
**Photo 15. View looking north at Golden Gate left abutment and Funks Creek**

The left abutment is moderately steep with an average slope of about 1:1 (Photo 15). Unconsolidated deposits on this abutment consist of about 90 percent colluvial soil and 10 percent landslide deposits. It is underlain by about 65 percent sandstone and siltstone, and about 35 percent mudstone. The sandstones form topographic highs often protruding above the surrounding ground surface and the mudstones are commonly associated with topographic lows. These beds strike nearly north-south and dip about 50 degrees toward the east. Most joint fractures strike nearly east-west with a dip between 50 degrees south to 70 degrees north. Vegetation is light on the left abutment, consisting entirely of grasses except for a few heavier shrubs in the south-draining gully. Foundation preparation should include the removal of at least 12 feet of soil, colluvium, and intensely weathered bedrock using common methods, with another 20 feet of moderately weathered

bedrock that may need to be excavated. The material removed from the stripping probably can be used as random fill.

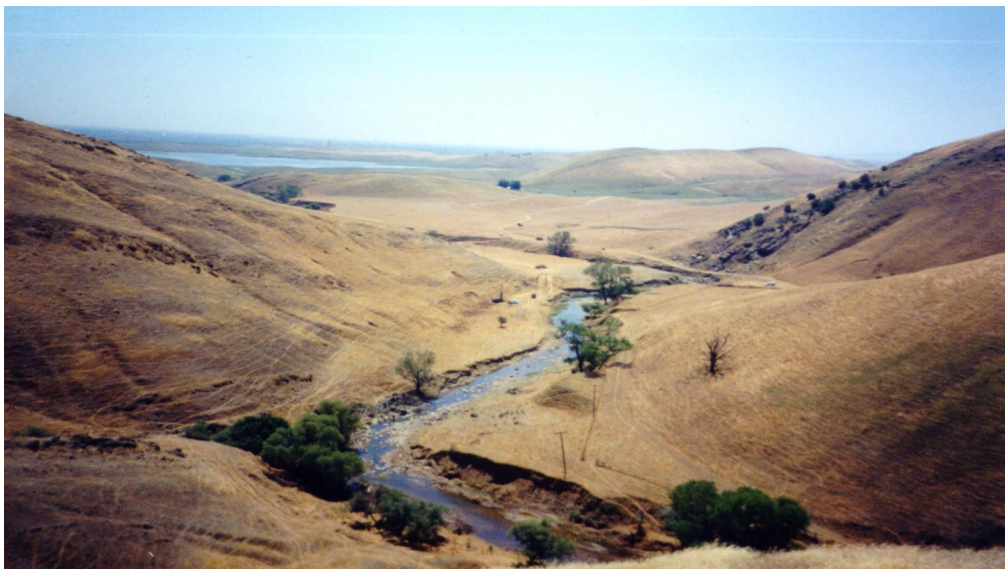
The Funks Creek channel varies from 150 to 600 feet in width, and is about 400 feet wide where it crosses the axis (Photo 16). Alluvial cover is moderate with stream channel deposits 5 to 8 feet thick and bordering terrace deposits up to 28 feet thick. Alluvium consists of sand and gravel with some sandy clay, cobbles, and boulders. Some more resistant sandstone outcrops in Funks Creek. Surface water flows occur in Funks Creek year-round but are generally low, so dewatering or diversion should be minimal. The channel has a fairly light and narrow riparian zone, consisting of scattered pockets of grasses, cottonwoods, and oak trees. These are somewhat thicker at the dam axis.

**Photo 16. Downstream view of Funks Creek channel of Golden Gate Dam site**

Foundation preparation should include the removal of up to 22 feet of alluvium, terrace deposits, minor landslide deposits, and intensely weathered bedrock using common methods. Another 2 to 10 feet of underlying moderately weathered bedrock may have to be excavated. A cutoff trench will probably be required below the core embankment. The excavated material can be used for random fill.

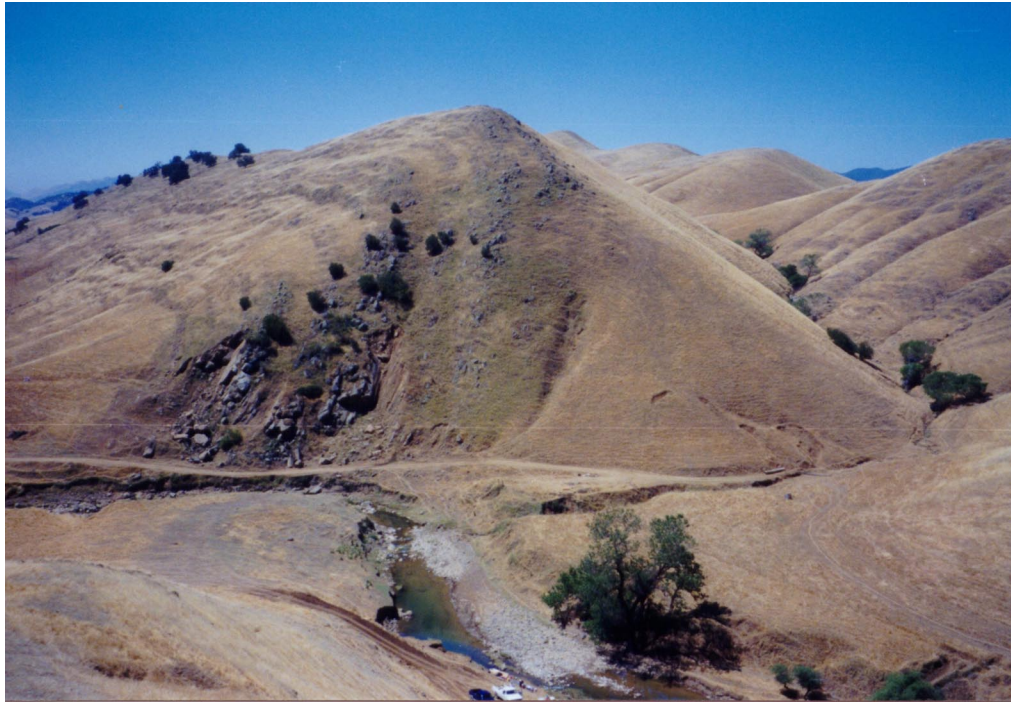
The right abutment is moderately steep with an average slope of about 1:1 (Photo 17). It is steeper at the toe where an old quarrying operation excavated and steepened the slope by blasting and removal of sandstone. Unconsolidated deposits

on this abutment consist of about 95 percent colluvial soil and 5 percent landslide deposits overlie the right abutment. About 70 percent sandstone and siltstone, with about 30 percent mudstone interbeds underlie the abutment. These beds strike nearly north south and dip about 50 degrees downstream toward the east. Most joint fractures strike nearly east west with a dip between 70 degrees south to 70 degrees north. Vegetation is light on the right abutment, consisting primarily of scattered grasses and very sparse oak trees scattered between outcrops along the ridge.

**Photo 17 . Southern view of right abutment of Golden Gate Dam site**

Foundation preparation should include removal of at least 5 feet of soil and colluvium, and intensely weathered bedrock using common methods, with another 20 feet of moderately weathered bedrock that may have to be excavated. The material removed from the foundation stripping probably can be used as random fill. An average stripping estimate is about 14 feet for the embankment and an additional 16 feet for the cutoff trench. A spring is located at the lower portion of the right abutment. An increase in the flow of water from the spring was observed while water pressure testing DWR drill hole RA-1 on the right abutment. This direct correlation indicates that there are open fractures in the abutment that would act as conduits for seepage. One possibility is that blasting from the quarry operation has widened existing joints and/or fractures.
